PHASE I INSPECTION REPORT
NATIONAL DAM SAFETY PROGRAM
OQUAGA CREEK STATE PARK DAM
I.D. NO. NY 783
DELAWARE RIVER BASIN
BROOME COUNTY, NEW YORK

PHASE I REPORT
NATIONAL DAM SAFETY PROGRAM

Name of Dam: Oquaga Creek State Park Dam
I.D. No. NY 783

Date of Inspection: November 7, 1979

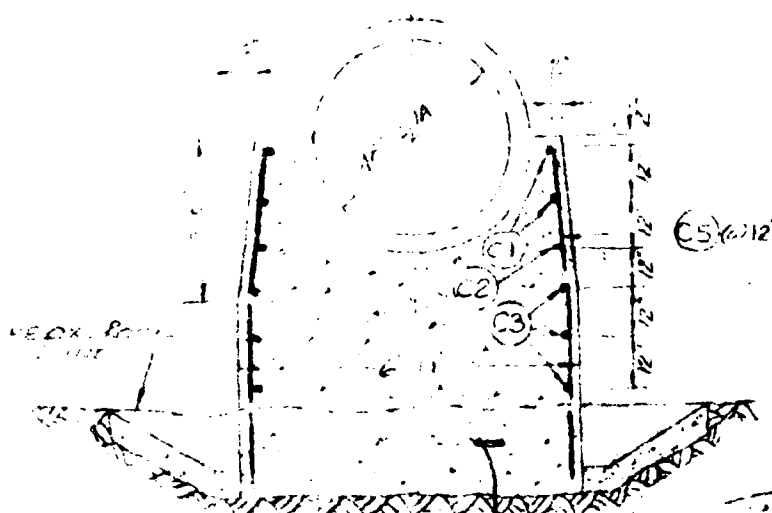
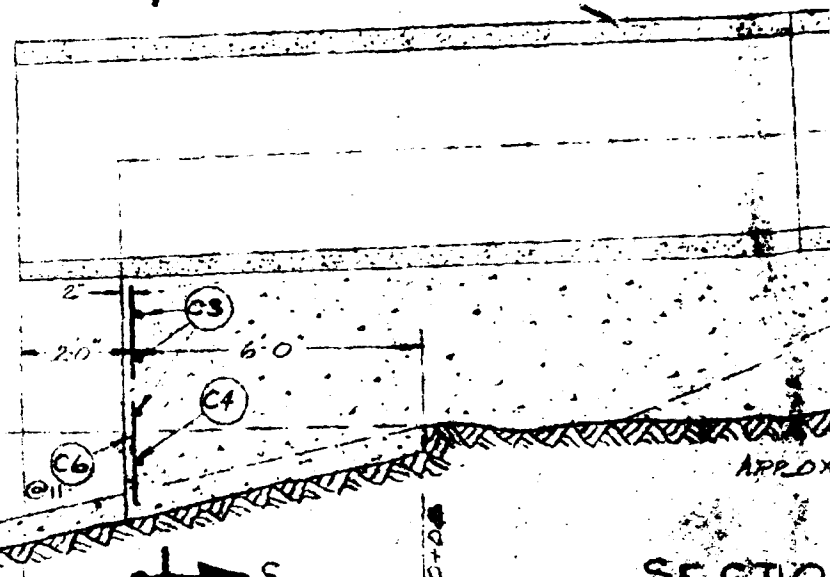
SECTION S-S

A lot of extra Concrete?
